Manhole Inspection Summary

Manhole # S05YY1012MH

Insp Date: **9/8/06 12:00 AM**

Location Address: **5903 BLAND AVE**

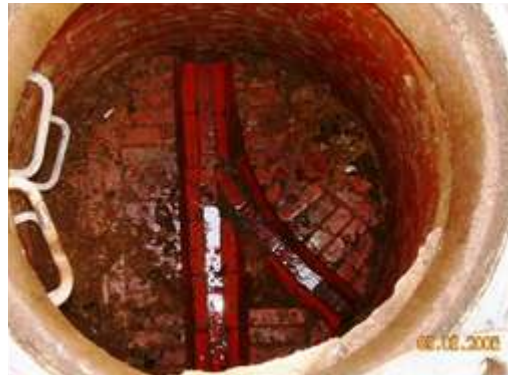
Top View

Frame leaks. Adjustment, Corbel, and Barrel infiltration. Evidence of surcharge - Bench debris.

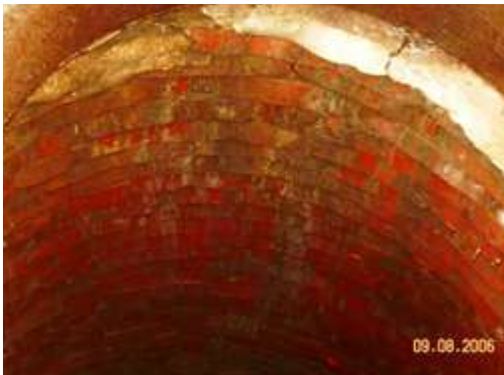
Defect

Adjustment deterioration. Adjustment and Corbel infiltration.

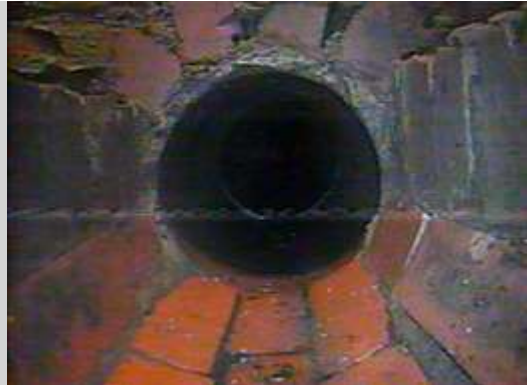
8 in. Circular Gravity Sewer Pipe Out @ 12 O'Clock

Comments **All of the pipe pictures show Barrel infiltration.**

Infiltration: **Evidence** Pipe Seal Cond: **Cracked**

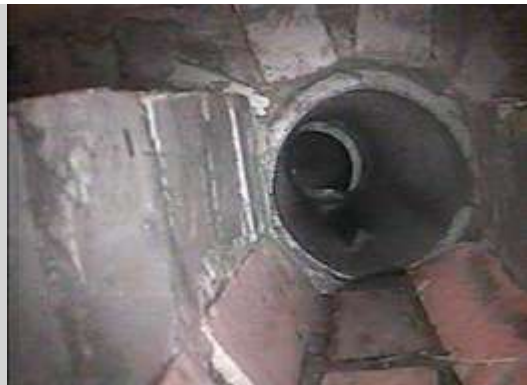
6 in. Circular Gravity Sewer Pipe Out @ 4 O'Clock

Infiltration: **None** Pipe Seal Cond: **Unknown**

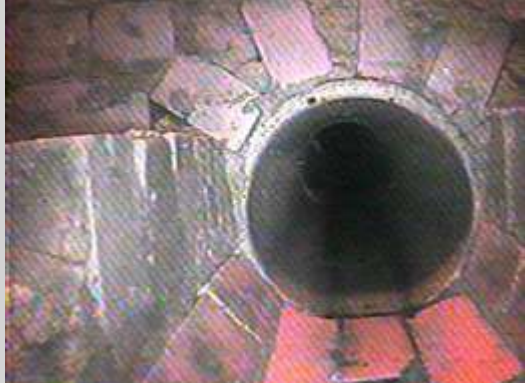
Pipe In @ 6 O'Clock

Infiltration: **Evidence** Pipe Seal Cond: **Cracked**
